case study

Strengthening of historic masonry with re-bar

Project:	Altes Bauamt Dietikon
Location:	Dietikon ZH, Switzerland
Engineer:	dsp Ingenieure + Planer AG
Architect:	stehrenberger architektur gmbh
Contractor:	Jäggi + Hafter AG / re-fer
Year:	2023
Installation time:	3 working days

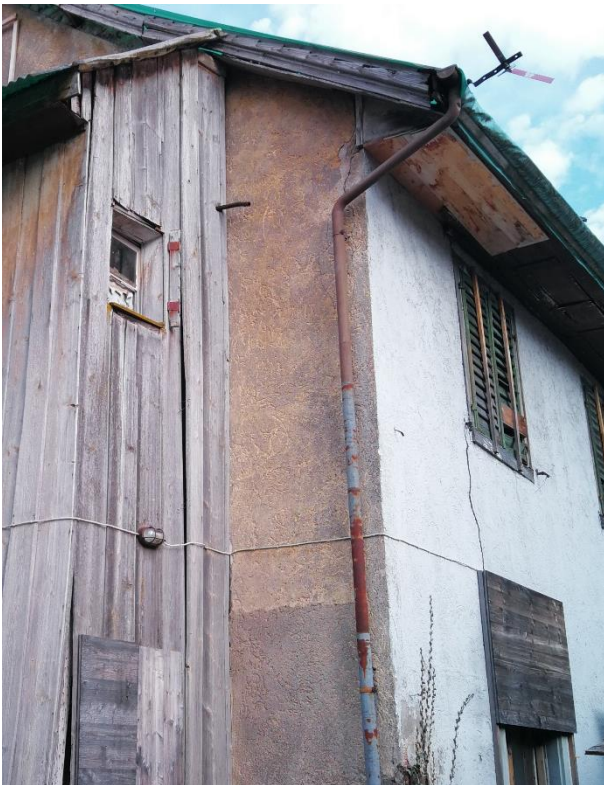
The supporting structure consists of rubble stone masonry and wooden ceilings. Founded on medium soil and small strip foundations, the building has experienced slight differential settlements over the centuries. The lime mortar joints of the sandstone walls are defective in some places. Especially between the ground floor and the upper floor, numerous vertical cracks have appeared.

Situation before, vertical cracks in masonry

Different cracks in the sensitive rubble stone walls at the level of the first floor were filled with mortar. The use of re-bar all around the building prevents these vertical cracks from reopening after the renovation due to vibrations damaging the new facade.

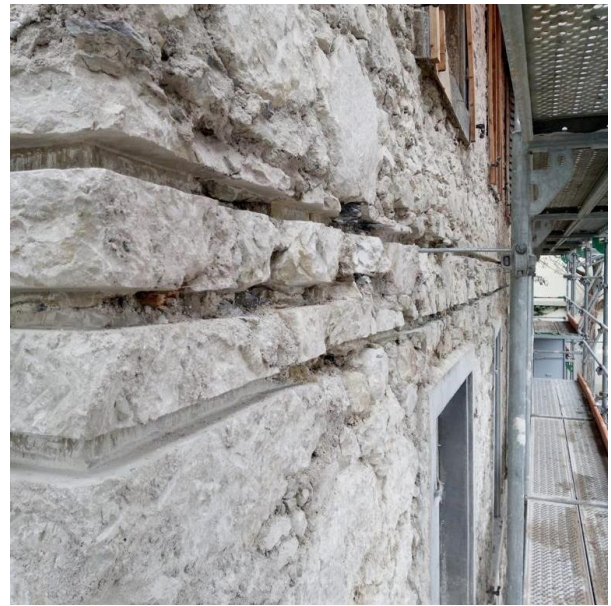
Grooves in rubble stone masonry

The entire building will be hollowed out and completely renovated. The roof truss and the wooden ceilings are replaced and renewed. Larger holes in the masonry are partially filled with spandrels (stone splinter wedges) and repointed with soft, low-cement lime mortar. A specialist cut grooves horizontally

around the building. In these, it was possible to place re-bars, which are bended around the corners for anchoring. The end areas are mortared. After curing, the re-bars can be heated and prestressed in a controlled manner, and are finally embedded in a soft mortar. The lightly tensioned ring around the building stops the masonry cracks from progressing.

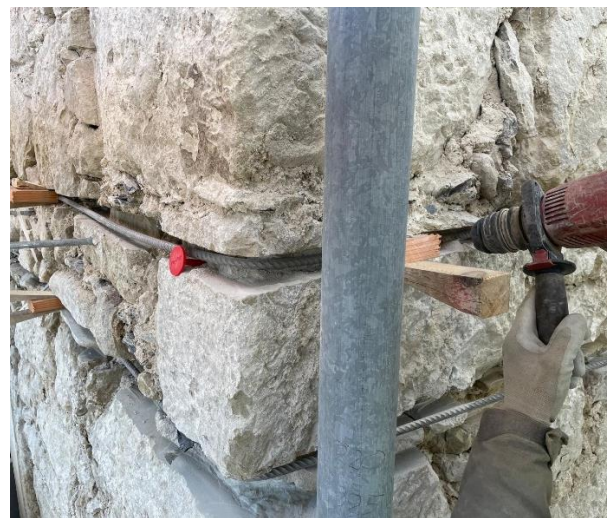
Positioning of the re-bar with end hooks in the corners

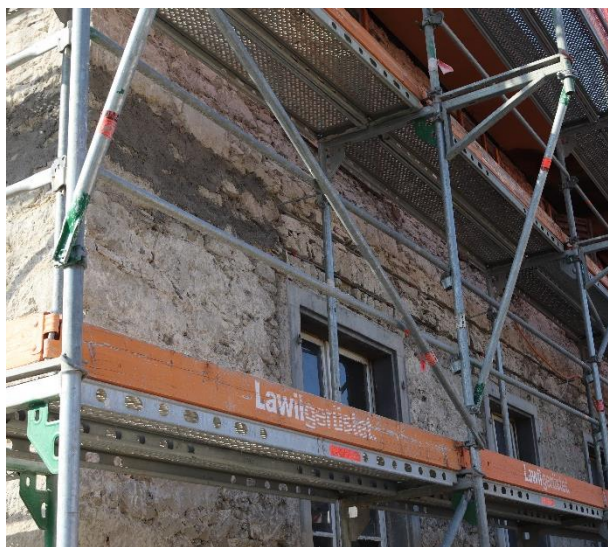
re-bar with mortar end-anchorage

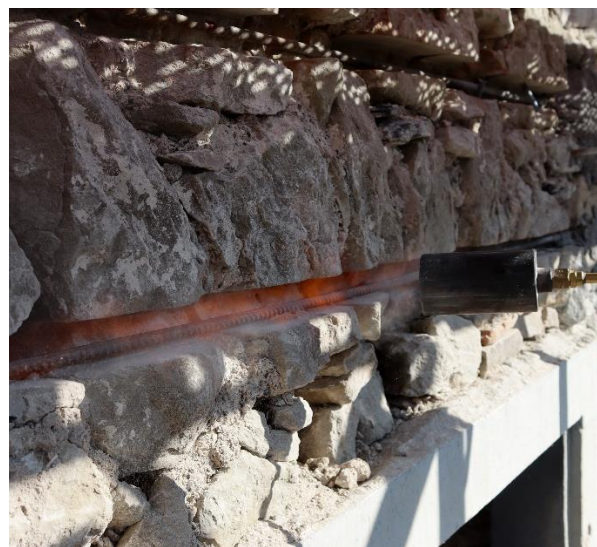
Activation of re-bar

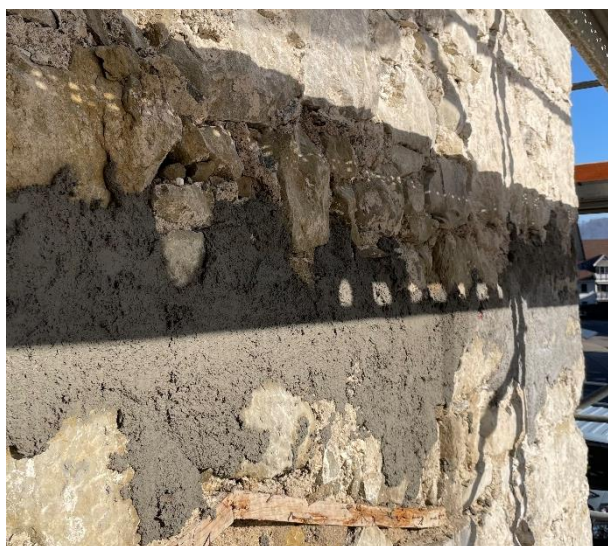
Sections in the middle are filled with mortar
