# case study

## Addition of punching shear reinforcement with re-bar 16

| <b>Project:</b> | Shopping center |
| <b>Location:</b> | Winterthur ZH, Switzerland |

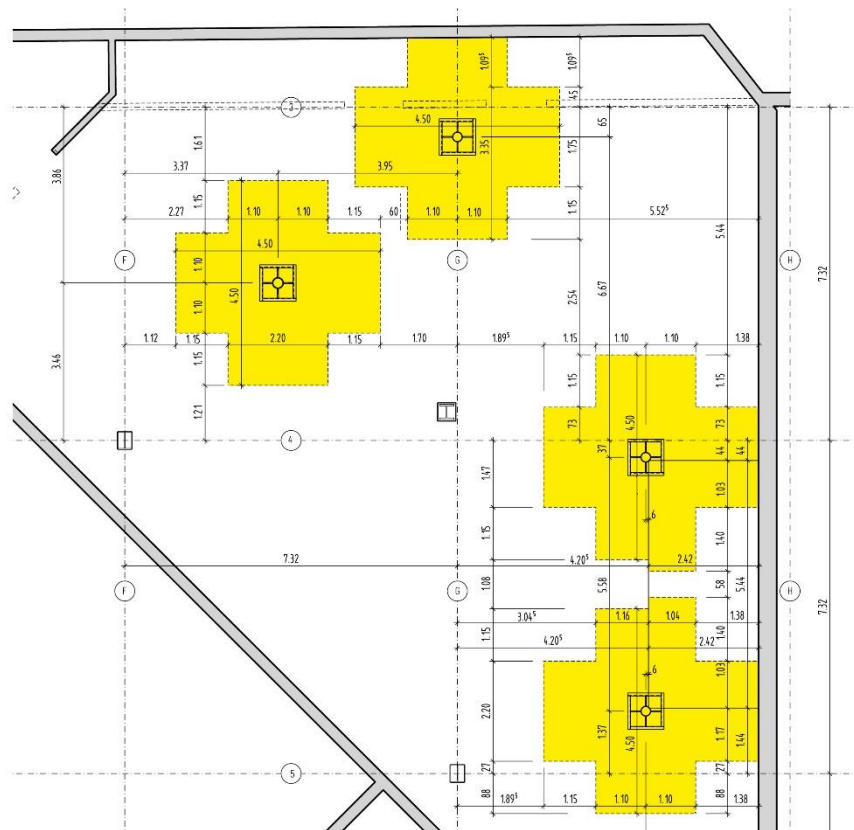
Plan detail (Knapkiewicz + Braunschweiler AG, Brünnen)

existing concrete floor. The column heads were fitted with external steel mushrooms. On the top of the ceiling, 16 bars were installed in these areas as prestressed bending reinforcement. In combination with the steel mushrooms of the column heads, this achieves the required punching shear resistance. At the same time, the newly arising negative bending moments are also covered.

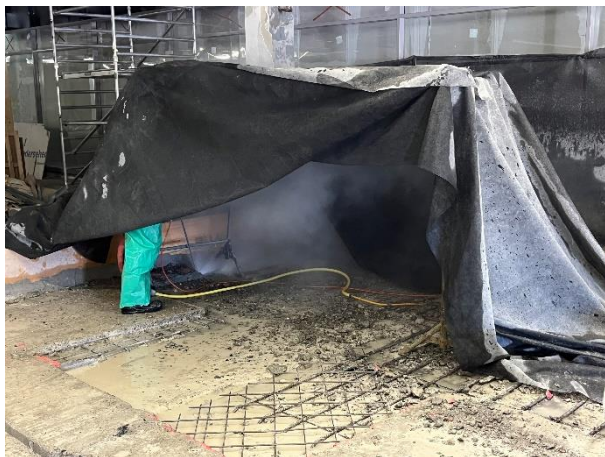
Hydromechanical removal

To install the re-bar reinforcement, the concrete surface in the area of the negative bending zone was hydromechanically removed in advance and the bars were then positioned. The end areas for the anchoring over a length of approx. 1.00 m were then filled with

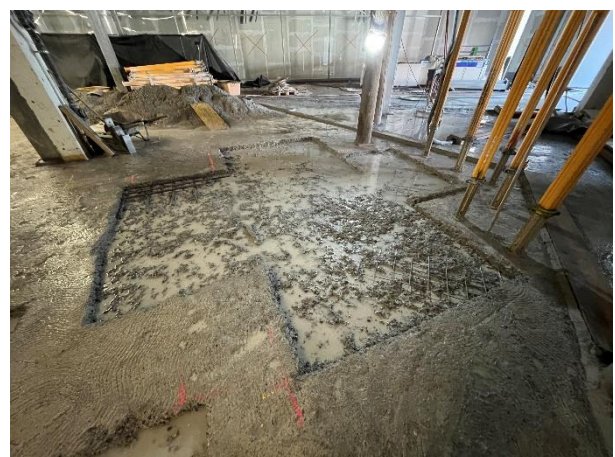
Reinforcement areas, waste disposal

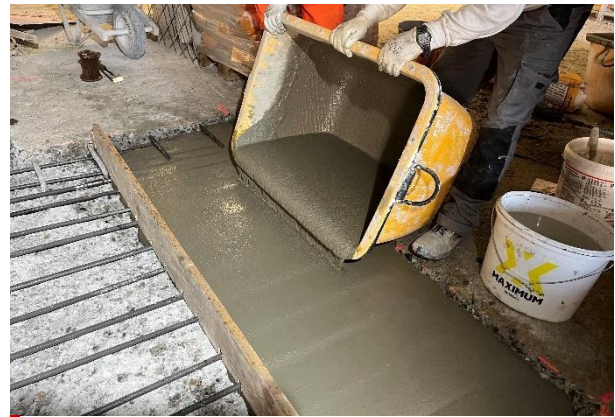
Grouting the anchoring areas

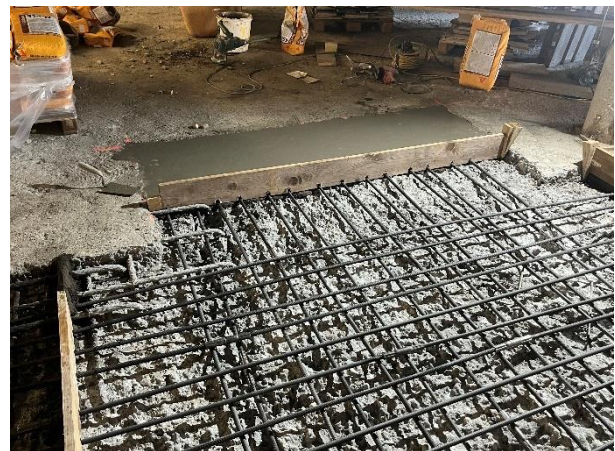
Grouting with SikaGrout®-314 N

SikaGrout<sup>®</sup>-314. A small mortar bed was made as formwork and a suitable timber formwork was mounted on top of it.

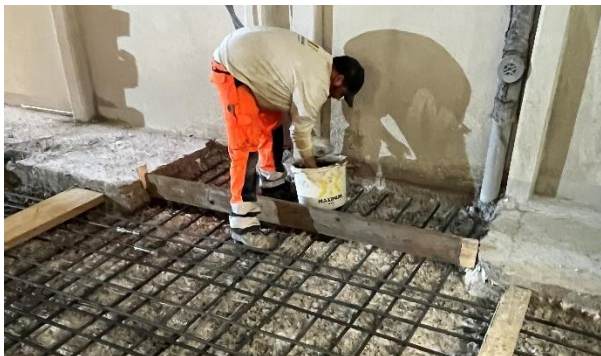
Preparation of formwork

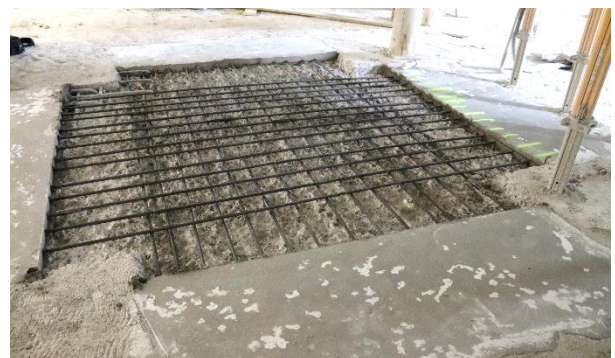
Hardened anchoring areas

Once the anchoring zones had hardened sufficiently, the bars were heated to a temperature of 300°C using a gas burner in order to create the shape memory effect and thus the prestressing. Finally, the free length between the anchoring zones was also filled with cement to create a system that was fully bonded with the concrete.

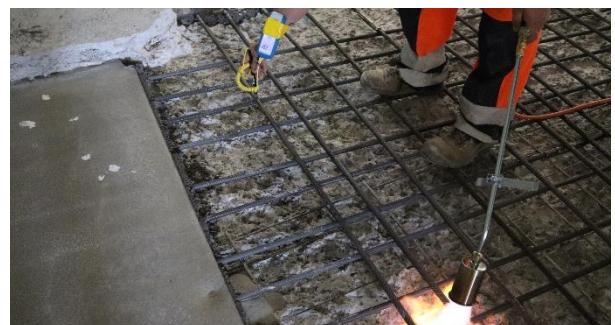
Activation of re-bar with gas and temperature control
